Revised **FULL RESERVE STUDY** The Jonathan Association

Chaska, Minnesota
Inspected - September 29, 2016
Revised - October 5, 2017

Client: The Jonathan Association (The Jonathan)

Reference: 090700

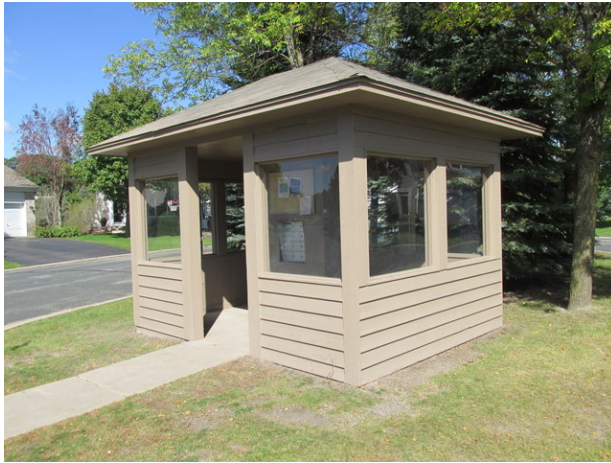
Bus Structures and Mail Pavilions - The Jonathan maintains 32 mail pavilions and bus shelters throughout the community. The pavilions and shelters comprise wood and composite hardboard siding, cedar shake and asphalt shingle roofs and acrylic windows. The Association also maintains one brick mail pavilion at Autumn Woods. These elements vary in ages, and the conditions vary from good to fair. We note paint finish deterioration and siding rot.

Mailbox pavilion at Autumn Woods

We recommend the Association budget for subsequent refurbishments every 20 years thereafter. We recommend the Association budget for repairs and paint finish applications between refurbishments and fund this maintenance through the operating budget.

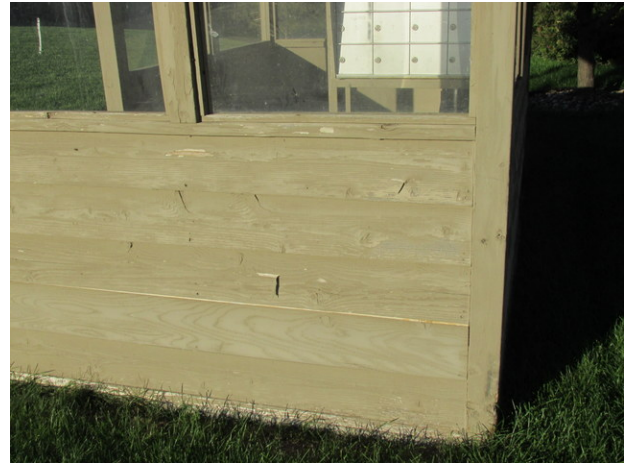
Paint finish deterioration at mailbox pavilion at Neighborhood 10

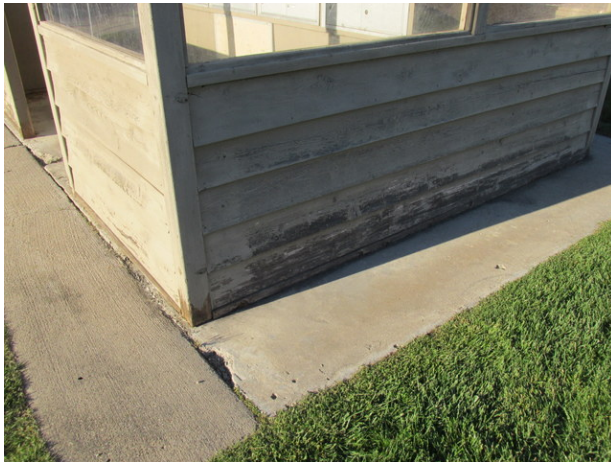
Typical paint finish deterioration

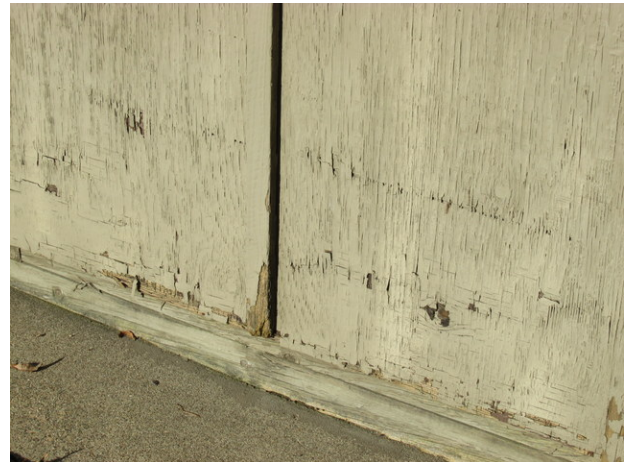
Siding rot at mailbox pavilion

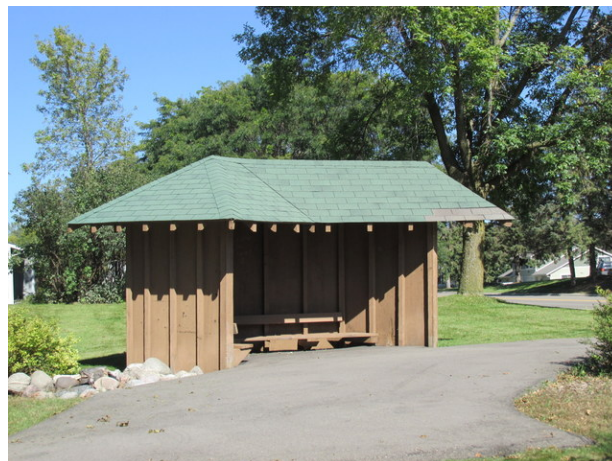
Bus shelter

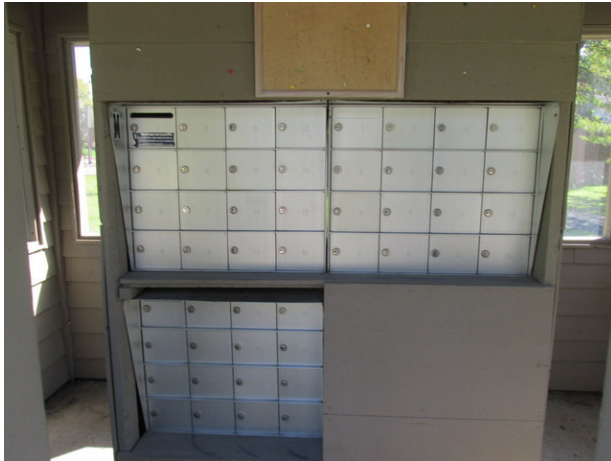
Metal mailboxes at mailbox pavilion

The mailboxes vary greatly in age and range in conditions from good to fair. The following table depicts the location, style and material, quantity and condition of the various types of mailboxes at The Jonathan:

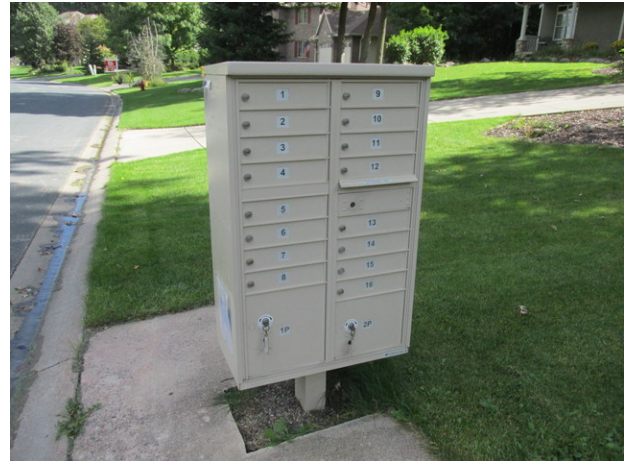
Mailbox stations

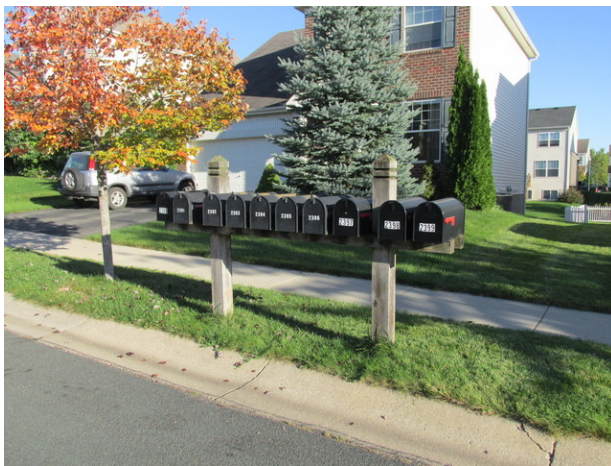
Wood mailbox stations

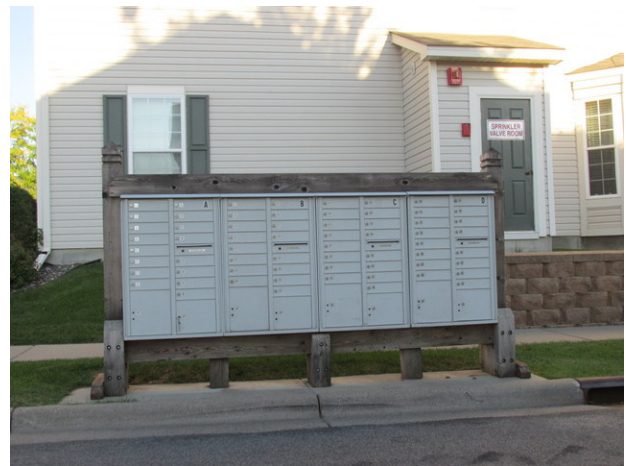
Metal mailbox stations

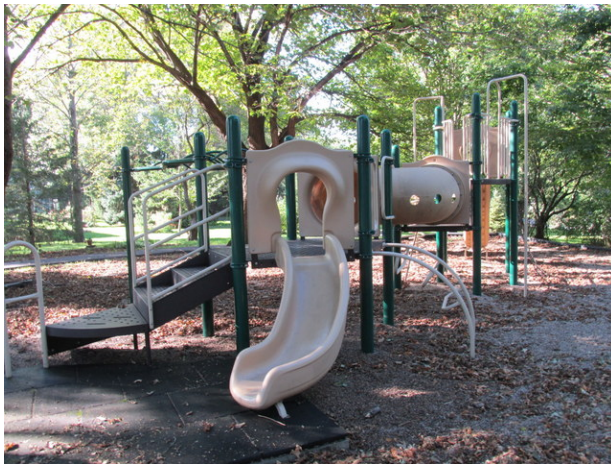
Playground Equipment - The Association maintains playground equipment throughout the neighborhoods. The playground equipment varies in age, and the condition varies from good

Playground at Neighborhood 9

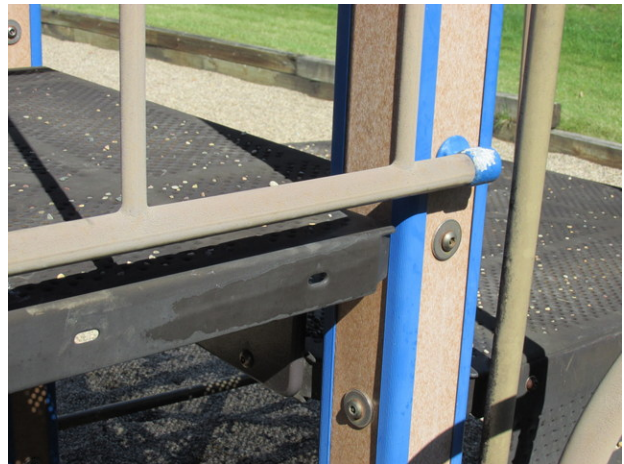
Finish deterioration and worn landing at play equipment

Safety is the major purpose for maintaining playground equipment. We recommend an annual inspection of the playground equipment to identify and repair as normal maintenance

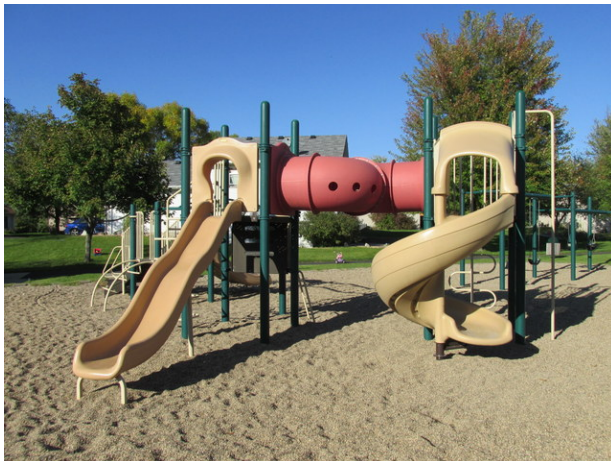
to fair. The Association replaced playground equipment at Neighborhood 7 in 2011 and at Neighborhoods 4, 5 and 11 in 2012. Management informs us the Developer may fund the replacement of the playground in Clover Preserve in 2017. Future updates to the study will consider any changes and adjust the time of replacement accordingly. The ages of the remaining pieces of playground equipment were not available at the time of our inspection.

Playground at Neighborhood 7

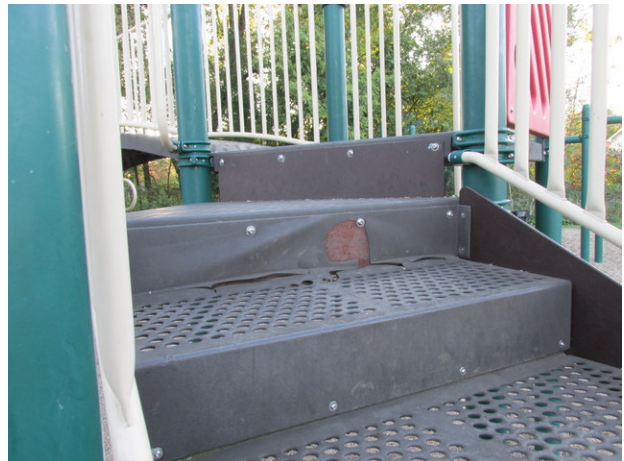
Coating deterioration at playground stairs at Neighborhood 11

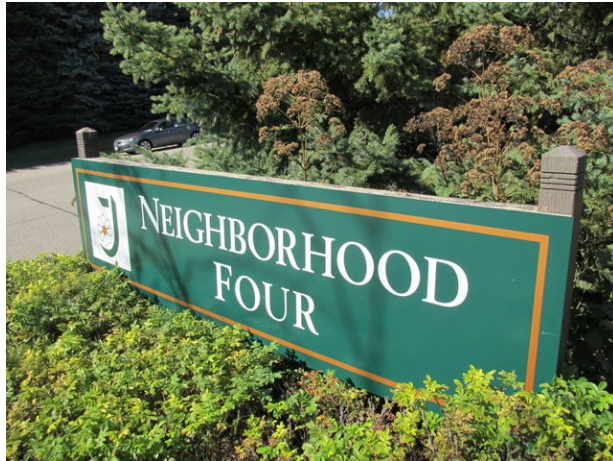
Signage - The Association maintains 31 various styles of community identification signs throughout The Jonathan. Nineteen are metal signs that are in good condition at less than one year of age. The remaining monuments comprise brick, stucco, wood concrete and composite

Typical new aluminum sign

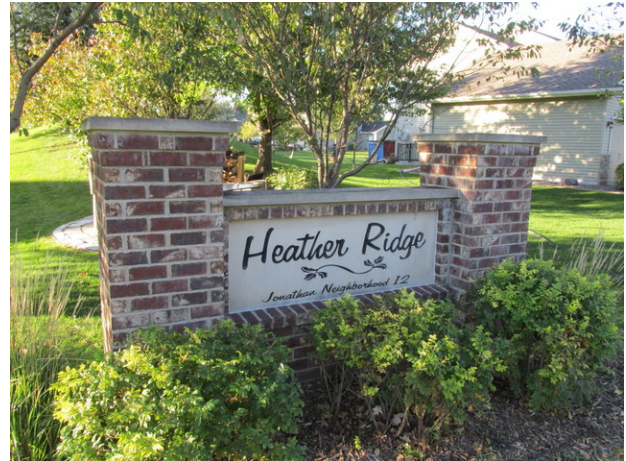
and vary in age, and the condition varies from good to poor. We note stucco cracks and loose masonry at the monuments and new metal signs throughout the property.

Stone monument sign

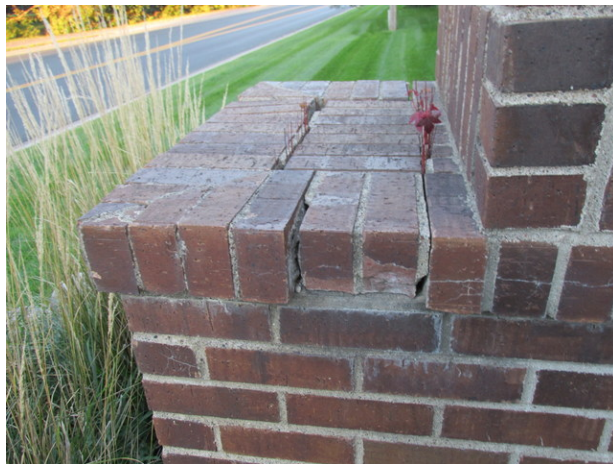
Brick cracks at Neighborhood 11 entrance monument

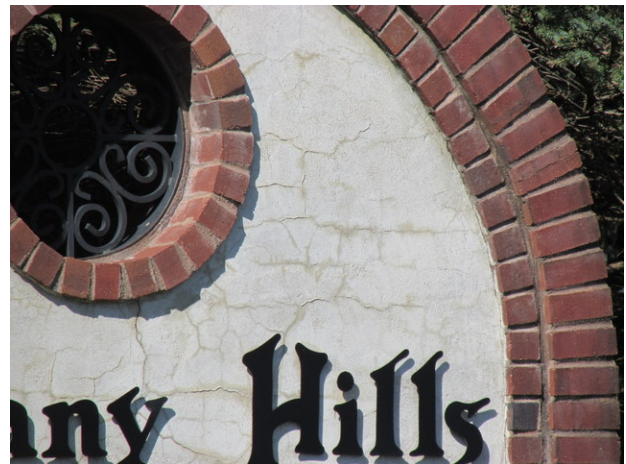
Stucco cracks at Neighborhood 10 at entrance monument

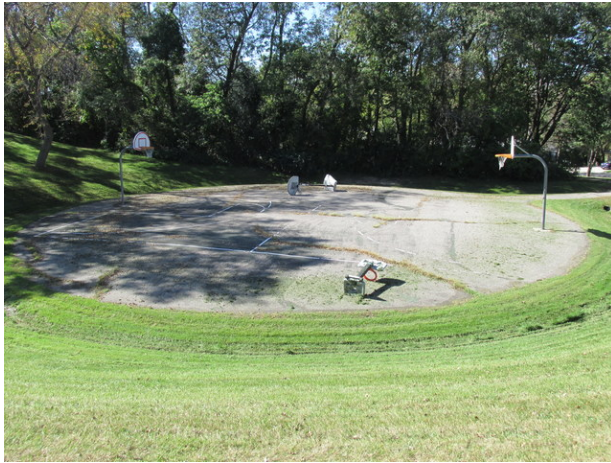
Asphalt Pavement, Basketball Court - The Jonathan maintains 600 square yards of asphalt comprising one basketball court at Neighborhood 6. The court is in poor overall condition at an unknown age. We note significant surface cracks and pavement deterioration.

Basketball court overview at Neighborhood 6

Basketball courts have useful lives of 15- to 20-years. Management informs us the Association plans to replace the basketball court in 2017. The Association should budget for subsequent replacement of the court by 2035. We note this information on Line Item 6.100 of *Reserve Expenditures*. We recommend replacement of the goal posts and hoops from the operating budget on an as needed basis

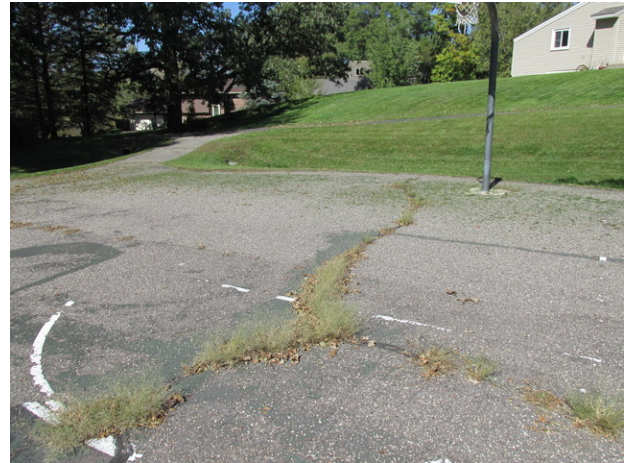
Surface cracks and deteriorated pavement

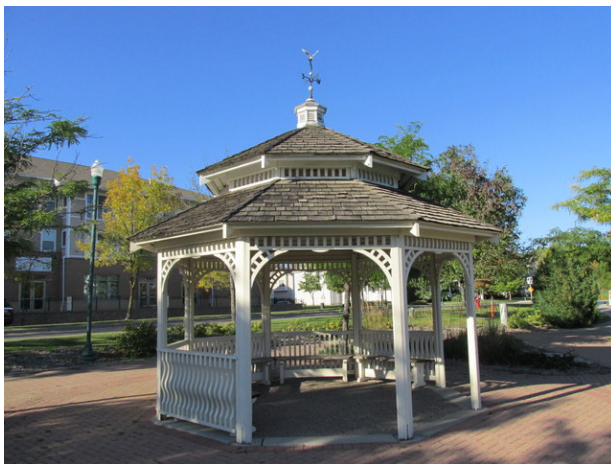
Gazebo - The Association maintains the wood frame gazebo near the roundabout at Clover Field. The gazebo is in good to fair condition at approximately 12 years of age. We note paint finish deterioration.

Gazebo at Clover Ridge

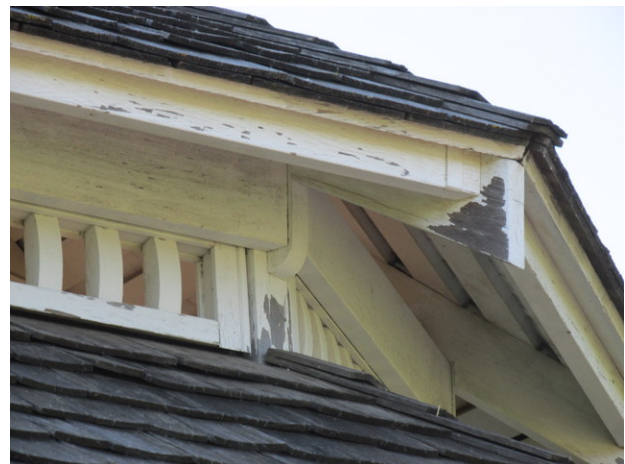
Paint finish deterioration at gazebo

Wood structures exposed to weather have a useful life of 15- to 25-years with periodic maintenance. We recommend The Jonathan budget for replacement by 2025 and budget for paint applications and repairs through the operating budget. A subsequent replacement is likely by 2045. We depict this information on Line Item 13.200 of *Reserve Expenditures*.

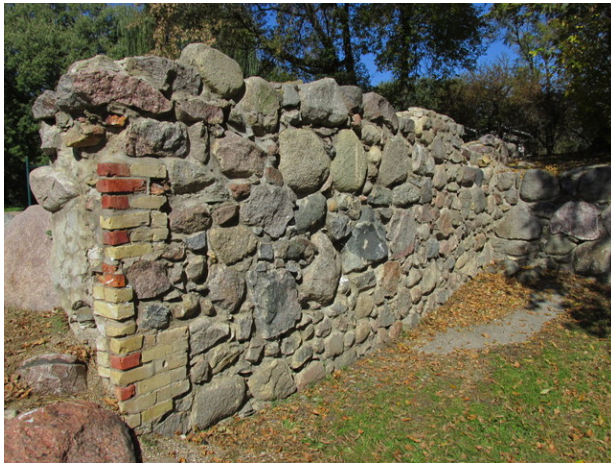
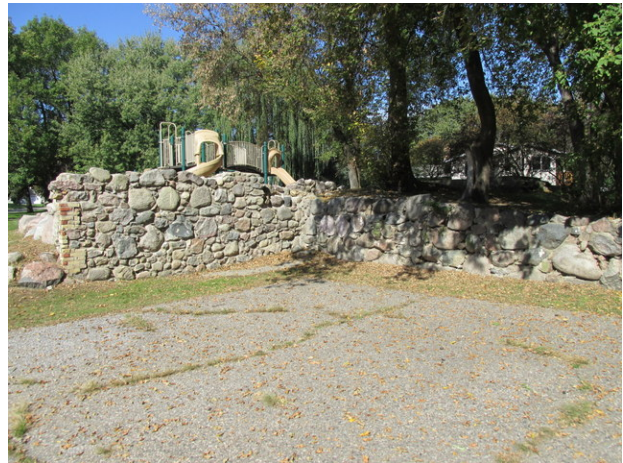
Retaining Walls, Masonry - The Association maintains masonry retaining walls at Neighborhoods 1 and 11 which comprise a total of 480 square feet of dry-set masonry and a stone retaining wall at Neighborhood 8 which comprises 400 square feet of stone masonry. The retaining walls vary in condition from good to poor at various unknown ages.

Retaining wall at Eitle House (Neighborhood 8)

We recommend the Association replace the stone masonry retaining wall at Neighborhood 8 with interlocking masonry at the time of replacement. Interlocking masonry retaining walls have useful lives of up to 35 years. We recommend the Association plan for replacement of the retaining walls at Neighborhood 1 by 2045, at Neighborhood 8 by 2019 and at Neighborhood 11 by 2034. We depict this information on Line Items 1.790, 8.790 and 11.790 of *Reserve Expenditures*. The Association should fund for repairs or partial replacements through the operating budget.

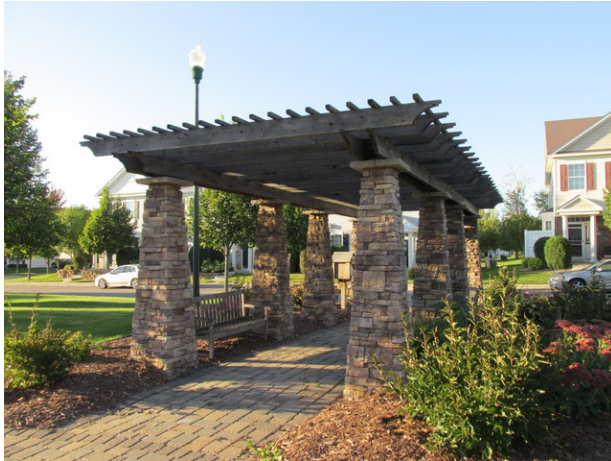
Trellis, Columns and Pavers - The Jonathan maintains one wood trellis with masonry columns over a walkway of brick pavers at Traditions. The wood trellis comprises 420 square feet and the brick pavers comprise 400 square feet. The trellis is in fair overall condition at an unknown age.

Trellis and masonry columns

These elements have a useful life of 15- to 25-years. We recommend the Association budget for replacement of the wood elements of the trellis and brick pavers and repairs to the masonry columns as needed by 2022 and again by 2040. We depict this information on Line Item 16.750 of *Reserve Expenditures*.

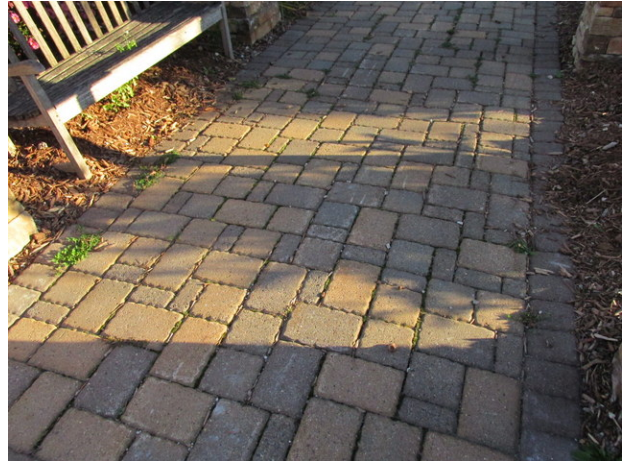
Minor settlement at brick pavers

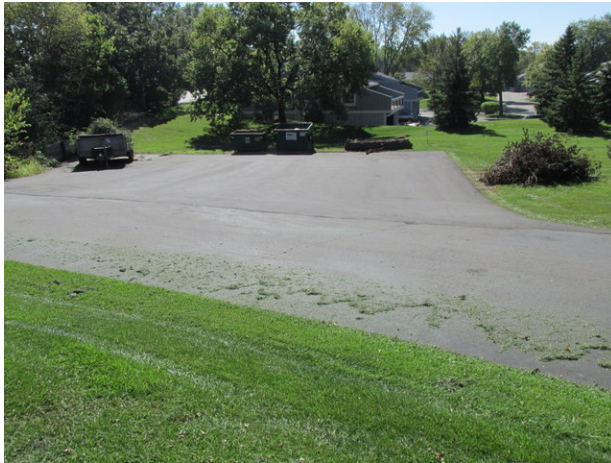
Asphalt Pavement, Repaving - Asphalt pavement comprises 1,850 square yards of driveway and parking areas at the Karen House. This quantity includes the pavement at the trash receptacles that was installed recently. The pavement is in good overall condition at less than five years of age.

Asphalt pavement at Karen House

The useful life of pavement in Chaska is from 15- to 20-years. We include the following repaving solutions and procedures for the benefit of the present and future board members.

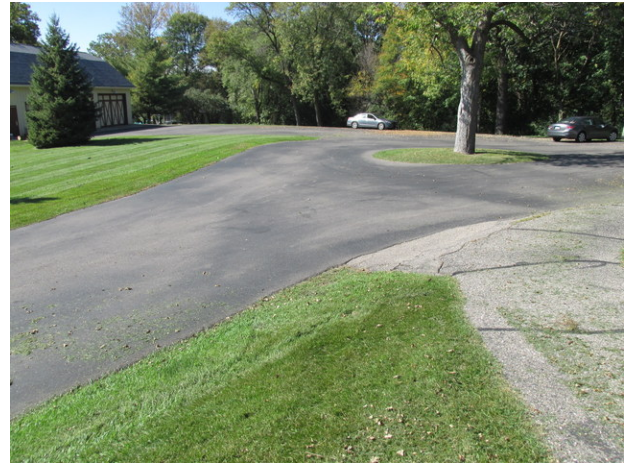
Asphalt driveway at Karen House

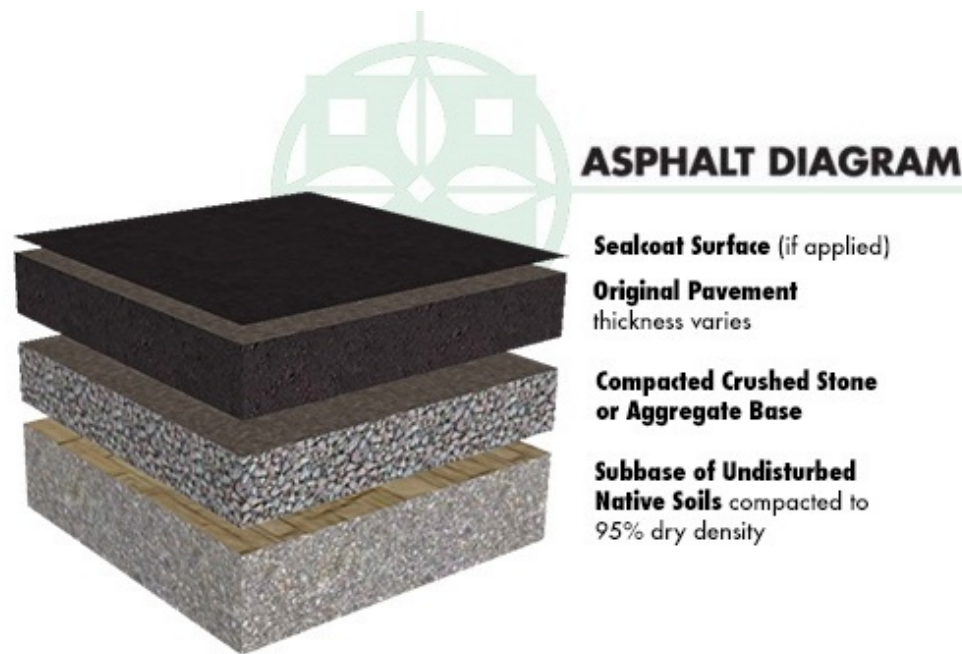
Components of asphalt pavement include native soil, aggregate and asphalt. First the contractor creates a base course of aggregate or crushed stone and native soil. The base course is individually compacted to ninety-five percent (95%) dry density prior to the application of the asphalt. Compaction assures a stable base for the asphalt that reduces the possibility of settlement. Driveway and access drive pavement is typically constructed with a compacted base and a single course of asphalt pavement. As such, the pavement is subject to greater wear from vehicle traffic, erosion, and effects of the freeze and thaw cycle. The following diagram depicts these components:

The manner of repaving is either a mill and overlay or total replacement. A mill and overlay is a method of repaving where cracked, worn and failed pavement is mechanically removed or milled until sound pavement is found. A new layer of asphalt is overlaid atop the remaining base course of pavement. Total replacement includes the removal of all existing asphalt down to the base course of aggregate and native soil followed by the application of two or more new lifts of asphalt. We recommend mill and overlayment on asphalt pavement that exhibits normal deterioration and wear. We recommend total replacement of asphalt pavement that exhibits severe deterioration, inadequate drainage, pavement that has been overlaid multiple times in the past or where the configuration makes overlayment not possible. Based on the apparent visual condition and configuration of the asphalt pavement, we recommend the total replacement method of repaving at The Jonathan.

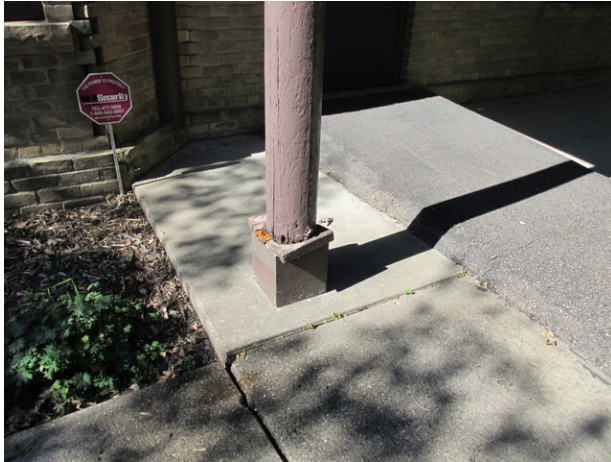
The Karen House exterior elements vary in age and are in fair to poor overall condition.

Rotten wood pillar

The useful lives of the Karen House exterior elements vary significantly. However, due to the relatively small quantities and interrelated nature of these elements, we recommend the Association combine their replacements into coordinated exterior renovations. Our renovation allowance excludes the roof with gutters and downspouts and windows and doors as we include replacement of these items on separate line items.

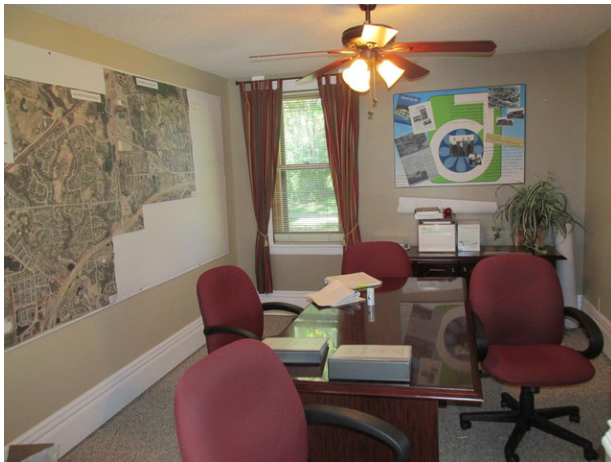
Interior Renovations – The Karen House interior comprises paint finishes, carpet and vinyl floor coverings, plumbing and lighting fixtures, kitchen cabinets and countertops and various appliances and furnishings. The Karen House interior elements are in fair overall condition at various ages.

Meeting room

Based on the age and visual condition of these interior elements, we recommend the Association budget for a coordinated complete interior renovation in 2018 and every eight years thereafter. We note this information on Line Item 19.500 of *Reserve Expenditures*.

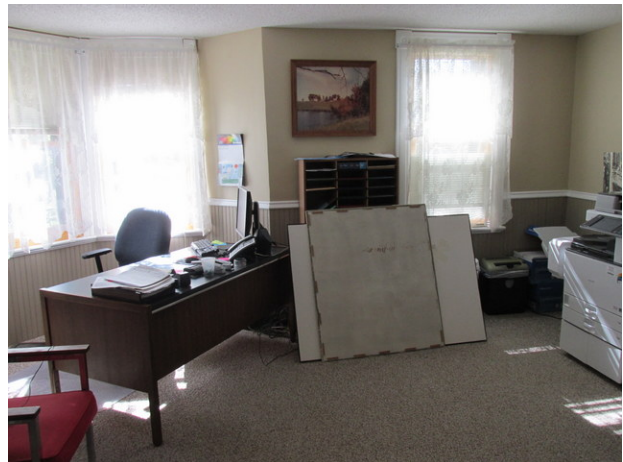
Office space

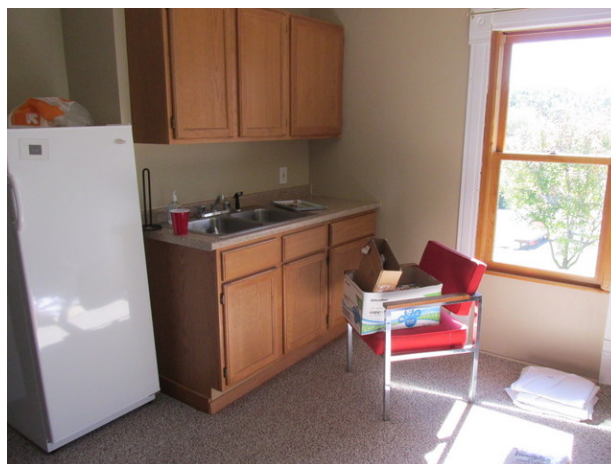
Upstairs kitchen and storage

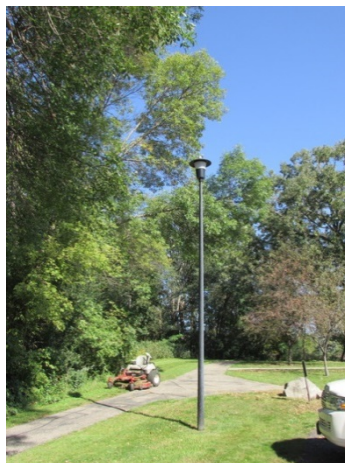
Light Poles and Fixtures - The Association uses four metal light fixtures atop metal poles to illuminate the Karen House.

Light pole and fixture at Karen House parking

These elements are in fair overall condition at an unknown age and have useful lives of up to 25 years. The Association should anticipate the need for replacement beginning by 2020

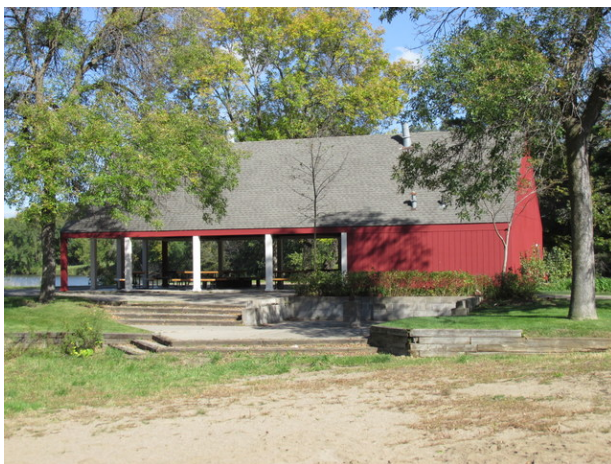
Landscape, Beach Hardscape - The Association maintains the concrete flatwork and shoreline at the Lake Grace beach next to the pavilion. Management informs us the Association plans to replace the concrete, install new retaining walls and replace the landscape at this location in 2017.

Location of future landscape repairs

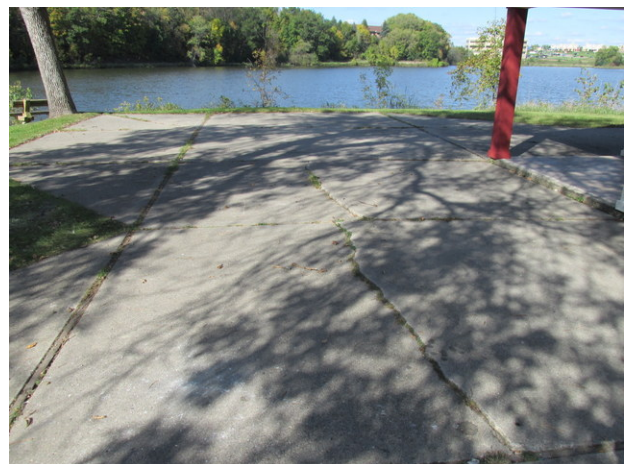
Concrete deterioration at pavilion

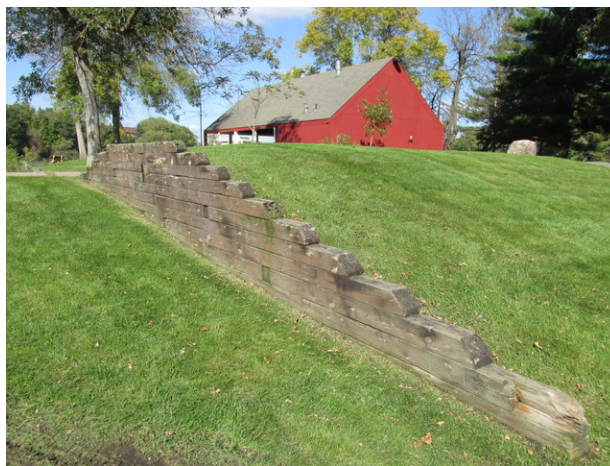
Retaining Wall, Timber - The Association maintains the retaining wall near the Lake Grace Pavilion that comprises approximately 340 square feet of wood timbers. The retaining wall is in fair to poor condition at an unknown age. We note leaning sections.

Leaning timber retaining wall near pavilion

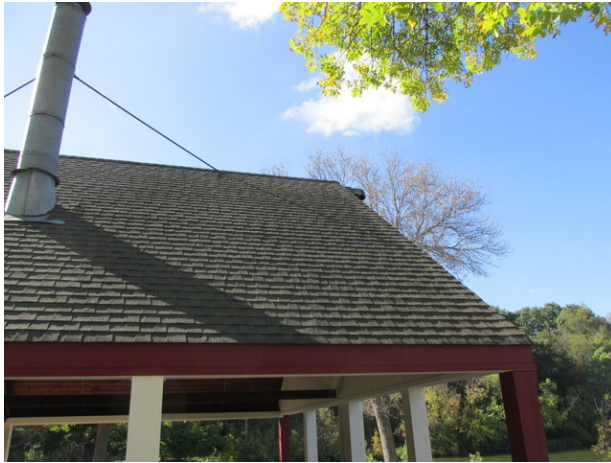
Roof, Asphalt Shingles - The Lake Grace pavilion roof comprises 25 squares of asphalt shingles. The roof is in good condition at less than one year of age.

Asphalt shingle roof

The useful life of an asphalt shingle roof is from 15- to 20-years. We recommend the Association anticipate complete replacement of the pavilion roof by 2034. We note this information on Line Item 20.280 of *Reserve Expenditures*.

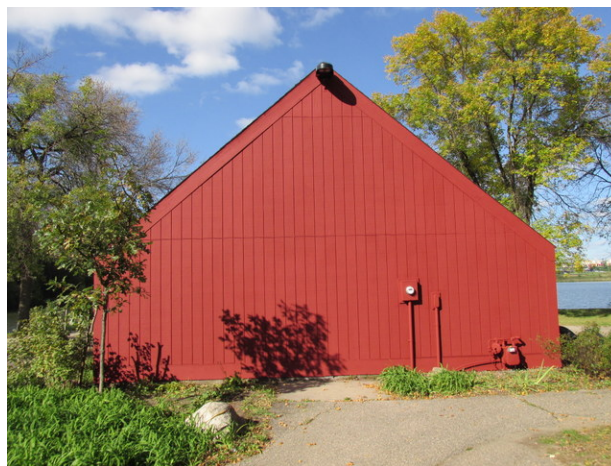
Walls, Wood Siding – Wood siding comprises approximately 2,050 square feet of the exterior walls at the pavilion. The siding is in good condition at less than one year of age.

Wood siding at pavilion

With the benefit of paint finish applications every four- to six-years, wood siding has a useful life of up to 35 years. Therefore, we do not anticipate the need to replace the wood siding within the scope of the study. The Association should budget for paint finish applications and

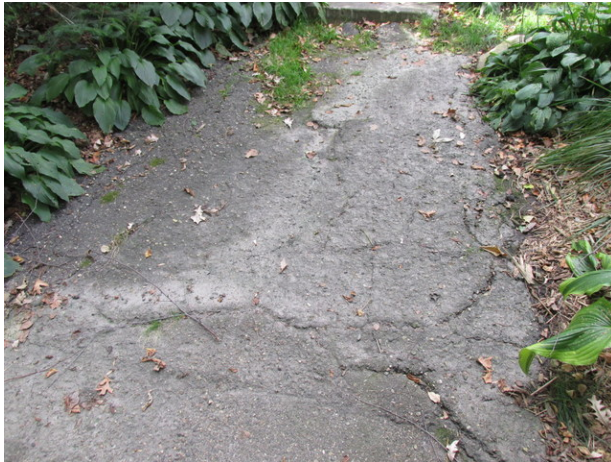
Asphalt Pavement, Walking Paths - The Association maintains approximately 37,350 square yards of asphalt walking paths throughout the neighborhoods at The Jonathan. These paths are in good to poor condition at various ages. We note repaired sections of walking paths in good condition and areas with significant pavement deterioration, cracks and settlement.

Walking path deterioration at Autumn Woods

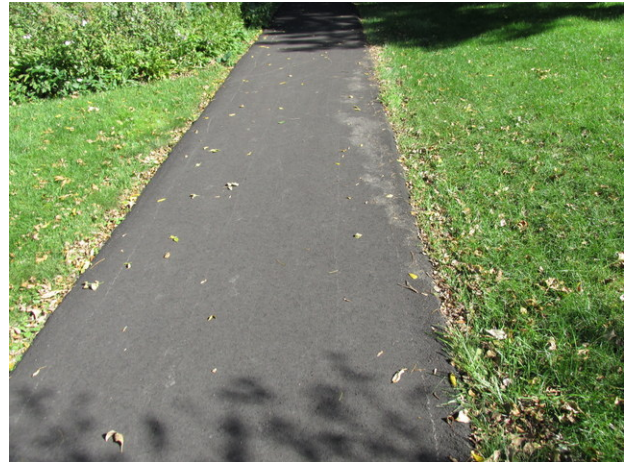
Replaced walking path near trail head

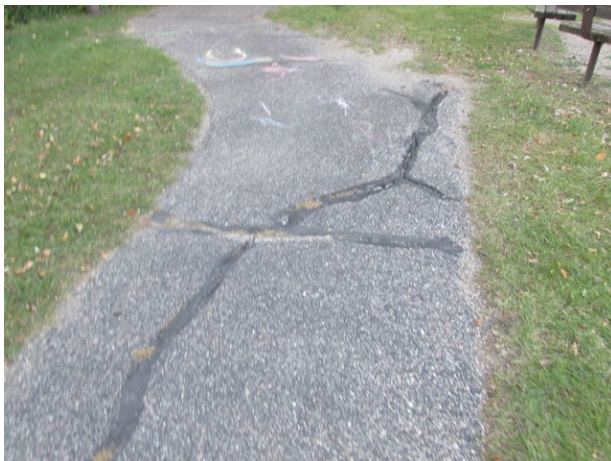
Walking path crack repairs at Neighborhood 5

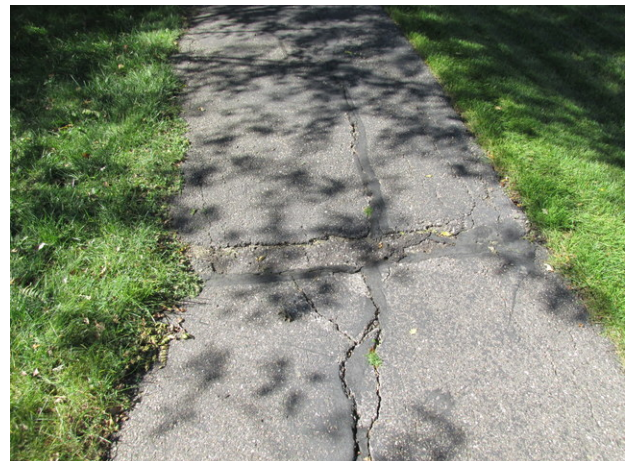
Asphalt pavement failure at Neighborhood 6

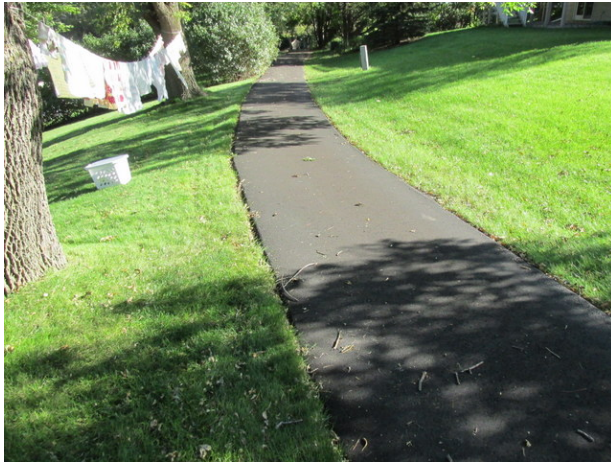
Recently replaced walking path at Neighborhood 9

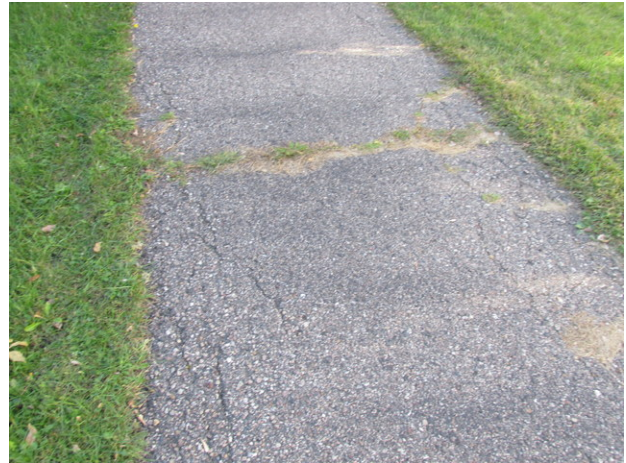
Pavement deterioration at Neighborhood 7

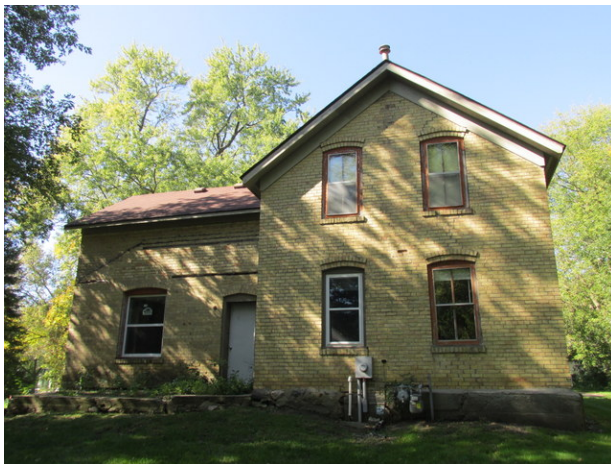
Eitel House – The Association maintains the Eitel House in Neighborhood 8. The Eitel House is in poor condition. Management informs us the Association will renovate the building to working condition so it may be used for meetings and events. The Eitel House is comprised of the following:

Eitel House building overview

The useful lives of these building elements vary significantly. However, due to the poor conditions, relatively small quantities and interrelated nature of these elements, we recommend the Association combine their replacements into coordinated renovations. At the request of Management we include an allowance of \$150,000 by 2019 for a total renovation of the Eitel House. We recommend the Association anticipate partial renovations every 20 years thereafter. At the request of Management, we include an allowance of \$90,000 by 2037 for partial renovations of the Eitel House. Line Items 21.100 and 21.150 of *Reserve Expenditures* note our estimate of future costs and anticipated times of exterior clubhouse renovations.

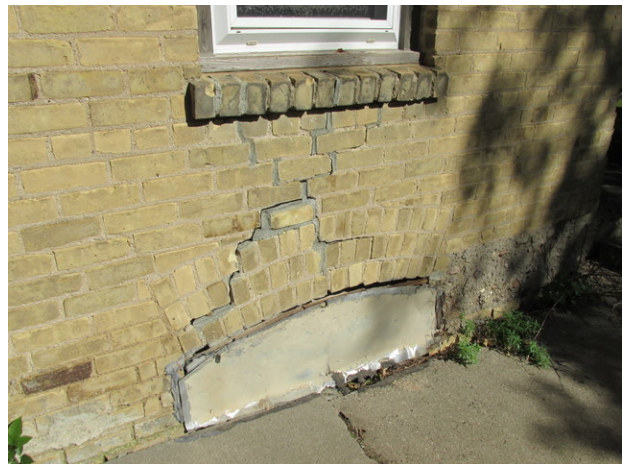
Masonry deterioration and typical step cracks at Eitel House

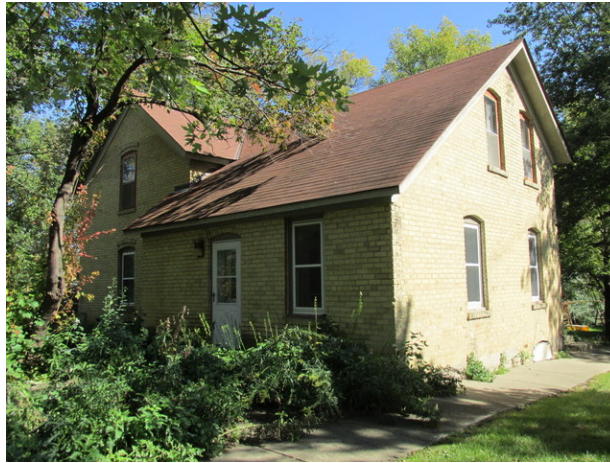
Eitel House building overview

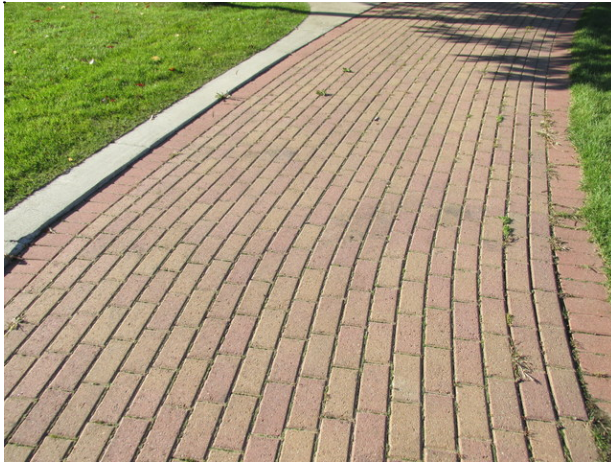
Pavers, Masonry, Clover Field – The Association maintains approximately 7,900 square feet of brick pavers at the roundabout on Hundertmark Drive and at the gazebo. The pavers are in good overall condition at approximately 10 years of age.

Pavers at gazebo

Masonry pavers have a long functional useful life. However, over time, the negative effects of inclement weather, erosion and pedestrian traffic will create isolated areas of deterioration. We advise the Association budget for complete replacement of the pavers every 15- to 20-years. We recommend the Association budget for a phased total replacement beginning by 2020 and concluding by 2026. A subsequent phased total replacement is likely beginning by 2040 and concluding by 2046. We depict this information on Line Item 21.620 of *Reserve Expenditures*. We suggest the Association conduct interim resetting and replacement of minor areas of pavers as normal maintenance, funded from the operating budget.

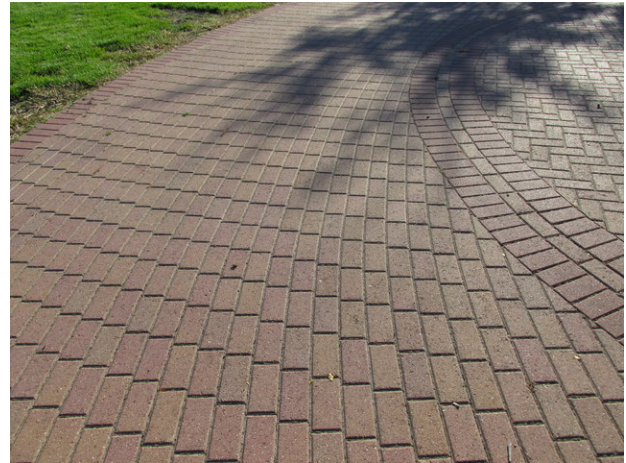
Pavers at gazebo

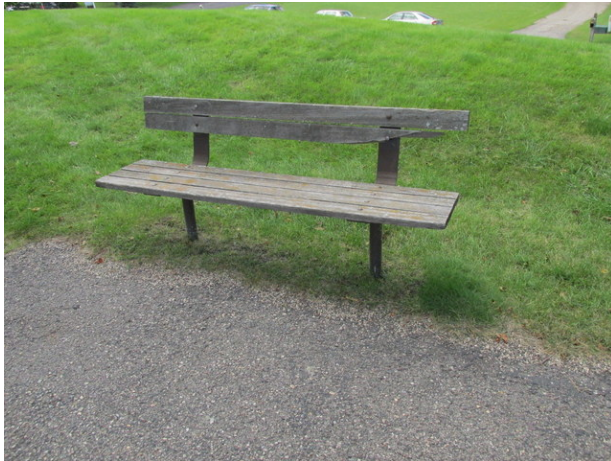
Site Furniture - The Jonathan maintains site furniture, including benches and picnic tables, doggy pots and trash receptacles throughout the property. The site furniture varies in age and the condition varies from good to fair.

Wood park bench

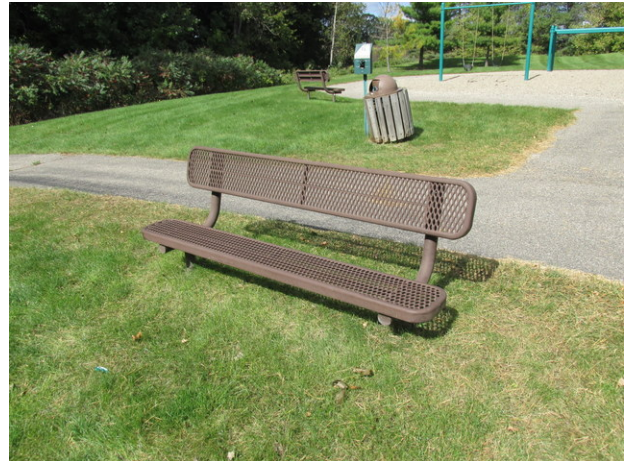
Metal park bench

These elements have a useful life of 15- to 20-years. We recommend the Association budget for the phased replacement of the furniture beginning by 2020 and concluding by 2032. A subsequent phased replacement is likely beginning by 2038. We depict this information on Line Item 21.820 of *Reserve Expenditures*.

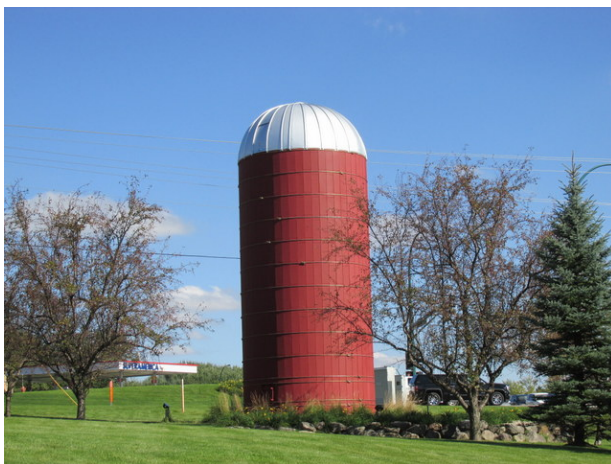
Silo - The Jonathan maintains the silo at the intersection of Hundertmark Road and North Chestnut Street near Neighborhood 4. The property identification silo was painted and banded in 2016. The paint finish is in good condition.

Silo near neighborhoods 3 and 4

We anticipate a useful life of five- to seven-years for the paint finish and include an allowance by 2023 and every five years thereafter. We depict this information on Line Item 21.900 of *Reserve Expenditures*. We base our cost on the historic project cost provided by Management.

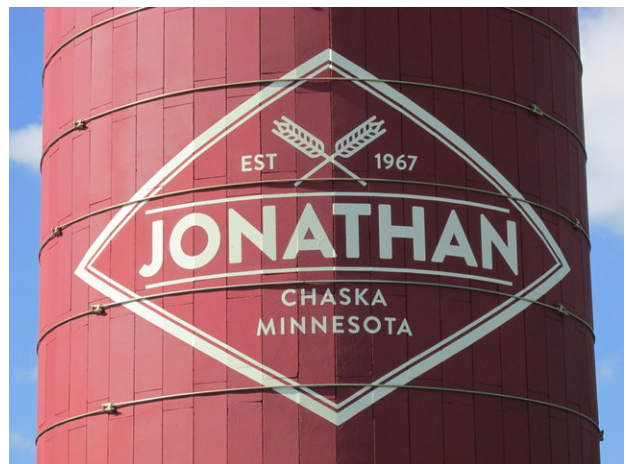
New paint application at silo

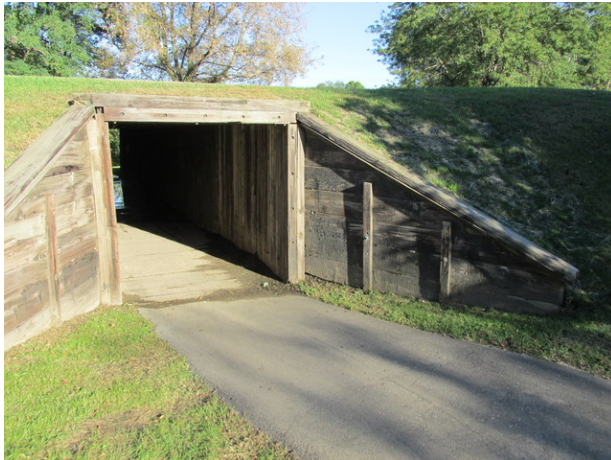
Underpasses, Timber - The Association maintains five underpasses that allow the bike path to continue under the streets throughout The Jonathan. These underpasses comprise wood structures and timber retaining walls. They vary in condition from good to fair at various unknown ages. We note soil loss and wood rot.

Walking path underpass at street

Timber structures like these have a useful life of up to 40 years with the benefit of regular inspections and partial repairs. We recommend the Association budget for inspection and partial repairs to the wood underpasses every 10- to 15-years and include an allowance for this work by 2018. We recommend the Association anticipate replacement by 2030. We include this information on Line Items 21.970 and 21.980 of *Reserve Expenditures*.

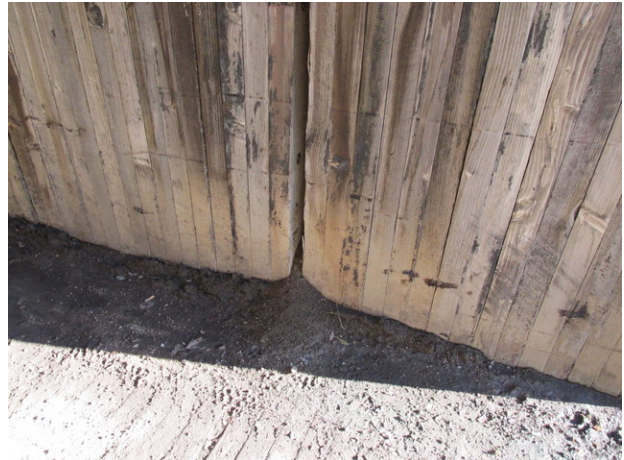
Soil loss at wood

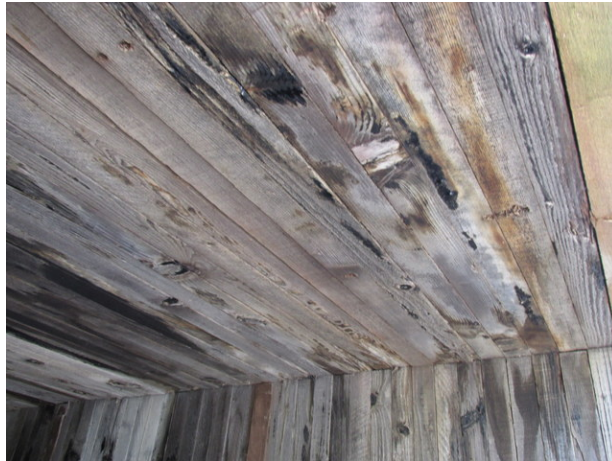
Wood rot at underpass

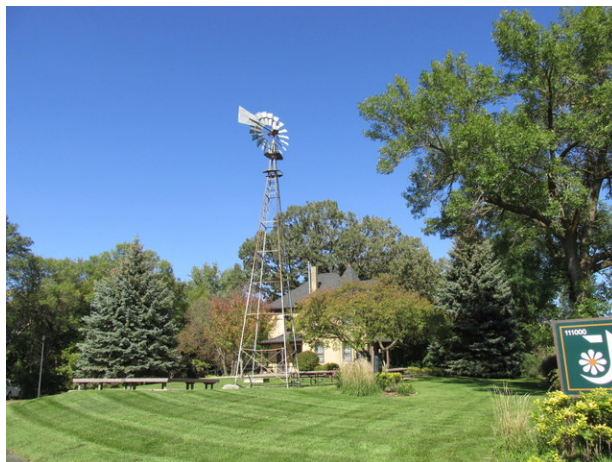
Windmills - The Jonathan maintains one windmill at the Karen House and one windmill at the Eitel House. The windmills are in fair condition.

Windmill at Karen House

The windmills have a useful life of up to 50 years. The Association should fund paint applications and repairs to the windmills through the operating budget as needed. We recommend the Association anticipate replacement by 2028. We depict this information on Line Item 21.990 of *Reserve Expenditures*.

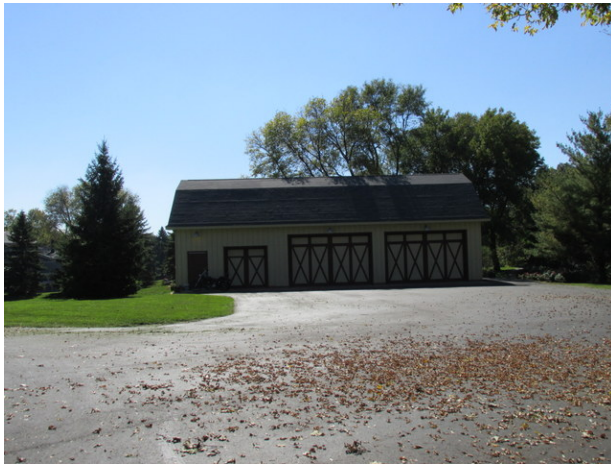
Front overview of storage building

Doors, Garage - The Association maintains the three garage doors at the storage facility near the Karen House. The garage doors are original to construction in 2011 and are in good overall condition. The garage doors have a useful life of up to 25 years. We recommend the Association anticipate replacement of the garage doors by 2036. We note this information on Line Item 22.050 of *Reserve Expenditures*.

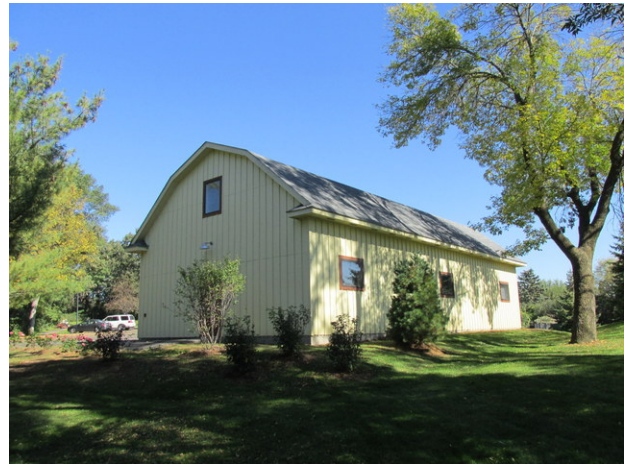
Rear overview of storage building

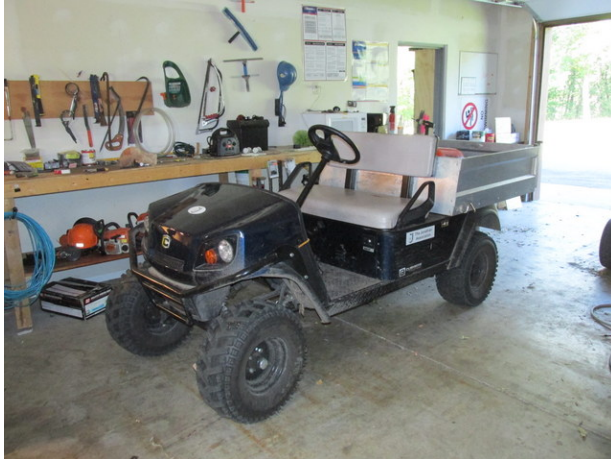
Pug golf cart

Maintenance Vehicle	Useful Life	Years of Replacement
Golf Cart	to 10	2021, 2031, 2041
Pickup Truck	to 10	2020, 2030, 2040
Trailer	10 to 15	2022, 2037
Utility Task Vehicle	10 to 15	2017, 2029, 2041

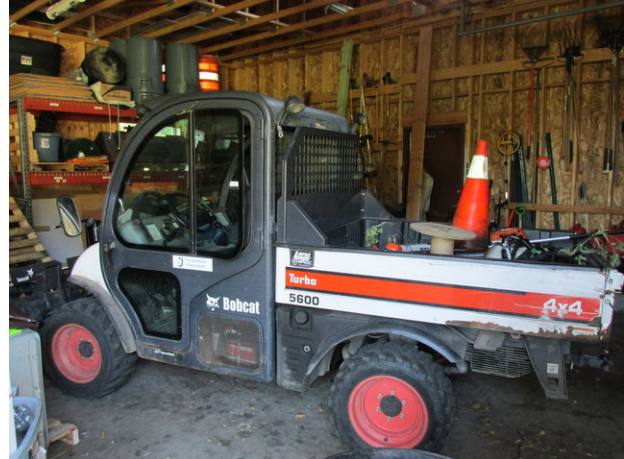
Management informs us the utility task vehicle has high use and they anticipate replacement in 2017.

Bobcat UTV

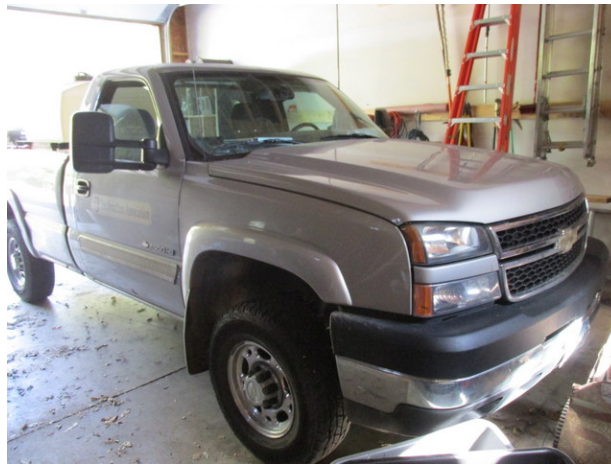
Pickup truck
