Revised **FULL RESERVE STUDY** The Jonathan Association

Chaska, Minnesota
Inspected - September 29, 2016
Revised - October 5, 2017

Client: The Jonathan Association (The Jonathan)

Reference: 090700

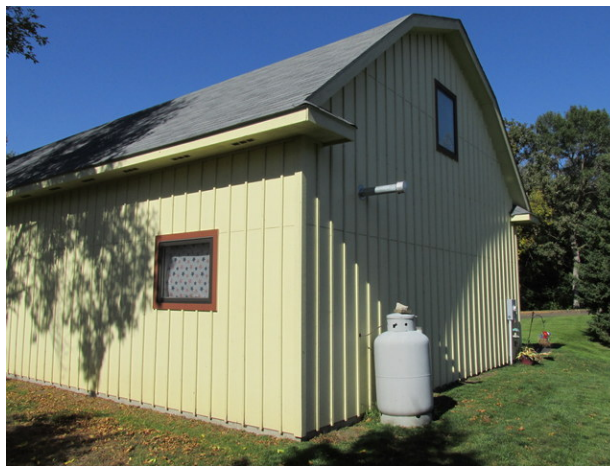
Roof, Asphalt Shingles - The storage facility comprises 23 squares of asphalt shingles. The roof is original to construction in 2011 and in good condition.

Asphalt shingle roof rake at storage building

The useful life of an asphalt shingle roof is from 15- to 20-years. We recommend the Association anticipate complete replacement of the storage facility roof by 2029. We note this information on Line Item 22.710 of ***Reserve Expenditures***.
